Reassessing the conservation and restoration activities of Champa temples in Ninh Thuan province, Vietnam

Tuyen Quang Dai

Faculty of Tourism

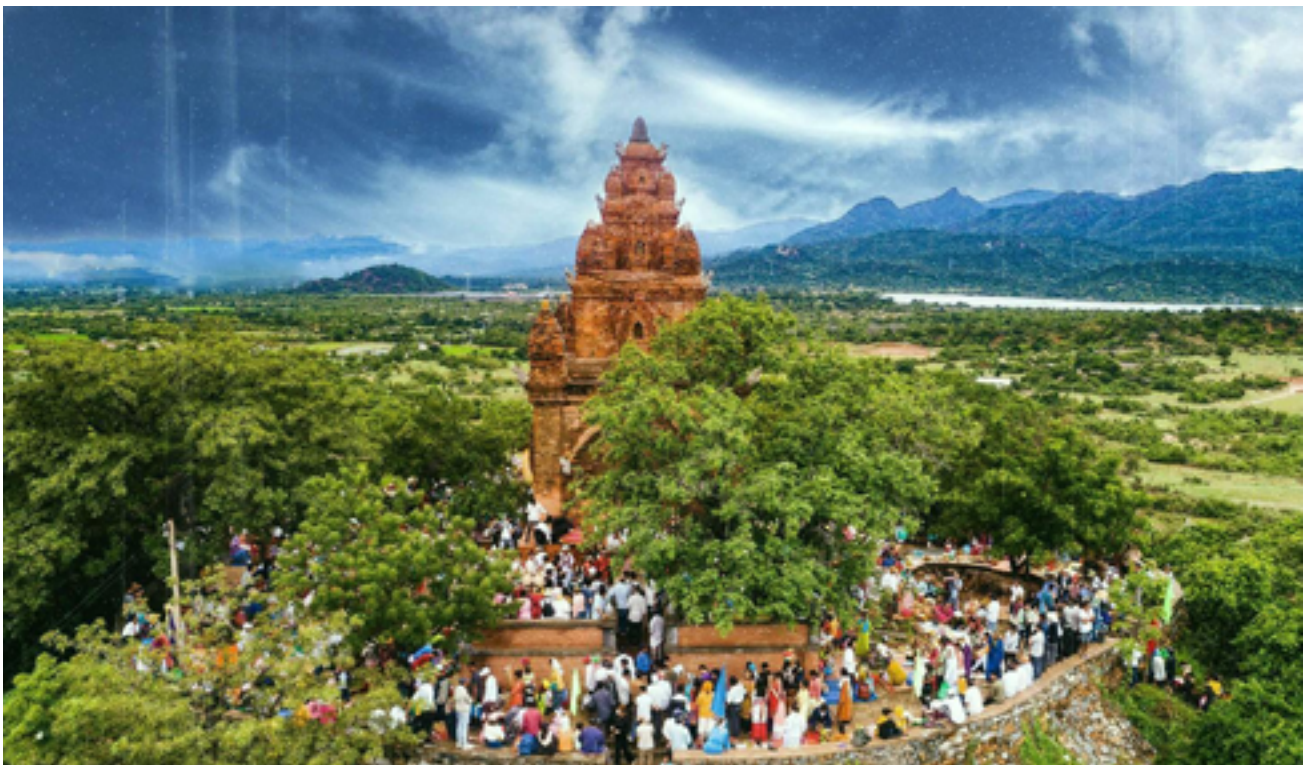
Fig. 2 The Po Rome temple. Source: **Photo** by Ja Khang, 2018.

The Po Romei temple, situated on a desolate hill covered with cacti and wild plants about two kilometers west of the Cham village in Ninh Phuoc district, is one of the cultural heritage sites in Ninh Thuan Province. It is a group of towers constructed during the final period of Cham architecture in the 17th and 18th centuries (Ngo Van Doanh 2002). The temple complex comprises a Kalan built in honor of King Po Rame, a temple dedicated to his wife, and his relative's tomb. In the past, it also housed a repository for offerings, but it has since been severely damaged, with only traces remaining today. The temple is considered the last tower showcasing the art, history, architecture, and sculpture of the Cham people.

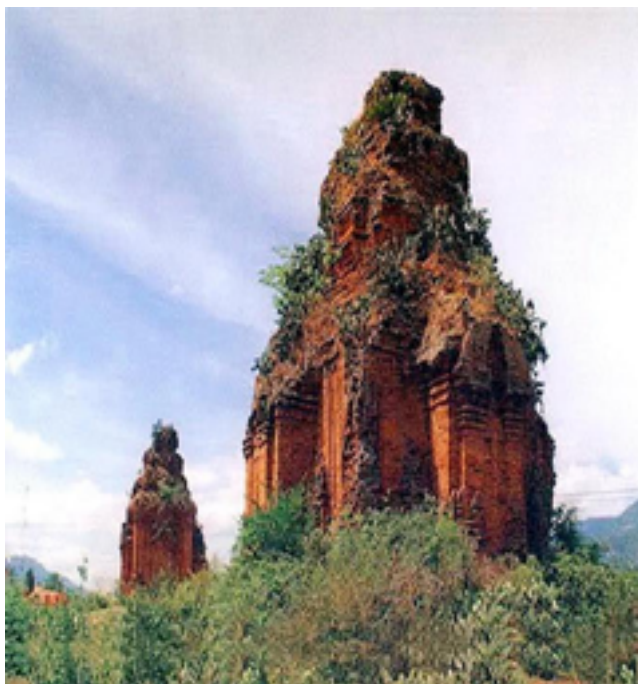
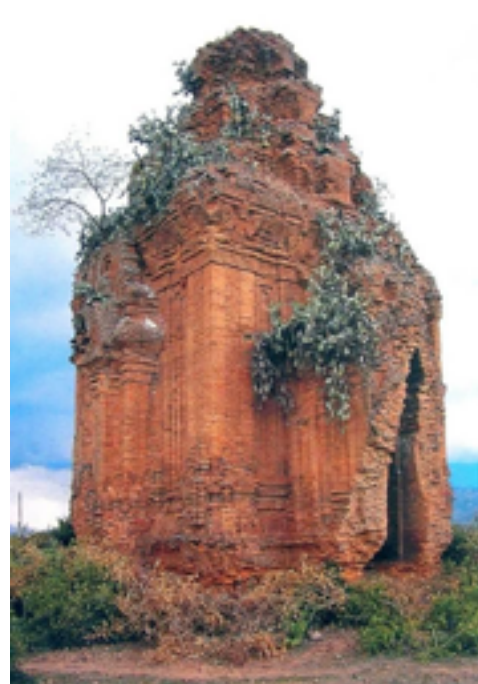
Figs. 3-4 Hoa Lai temple before conservation work. Source: Ninh Thuan Provincial Museum, 2000.

The Hoa Lai/Ba Thap temple, also known as Yang Bakran in the Cham language, is dedicated to the form of Shiva called Adidiveshavara (Schweyer 2011). Originally, the temple had three Kalans or towers, but the middle one was destroyed during the American War. In the early 20th century, French scholars discovered the remains of a wall that surrounded the three Kalans, as well as other structures such as a main tower (Mandapa) and a Gorupa (gateway tower) facing the central Kalan (Tran Ky Phuog 2008: 103). While the Hoa Lai complex is built in the traditional Cham style, its decorative patterns are unique, representing a style typical of the late 8th and early 9th centuries (Tran 2008: 106). Scholars consider the Hoa Lai temple the most valuable piece of art among the existing temples in Ninh Thuan Province (Ngo Van Doanh 2002; Parmentier 1909; Luu Tran Tieu et al. 2000). Parmentier described it as a masterpiece of ancient Cham architecture, featuring a multi-tower complex with unique design patterns that reflect cross-cultural influences. He also noted that the Hoa Lai style marked the end of the first phase of Cham art, featuring square shapes, symmetry, and no small decorative towers on the floor of the complex. The motifs include cylindrical flower motifs and naturalistic foliage (Parmentier 1909: 118–120).

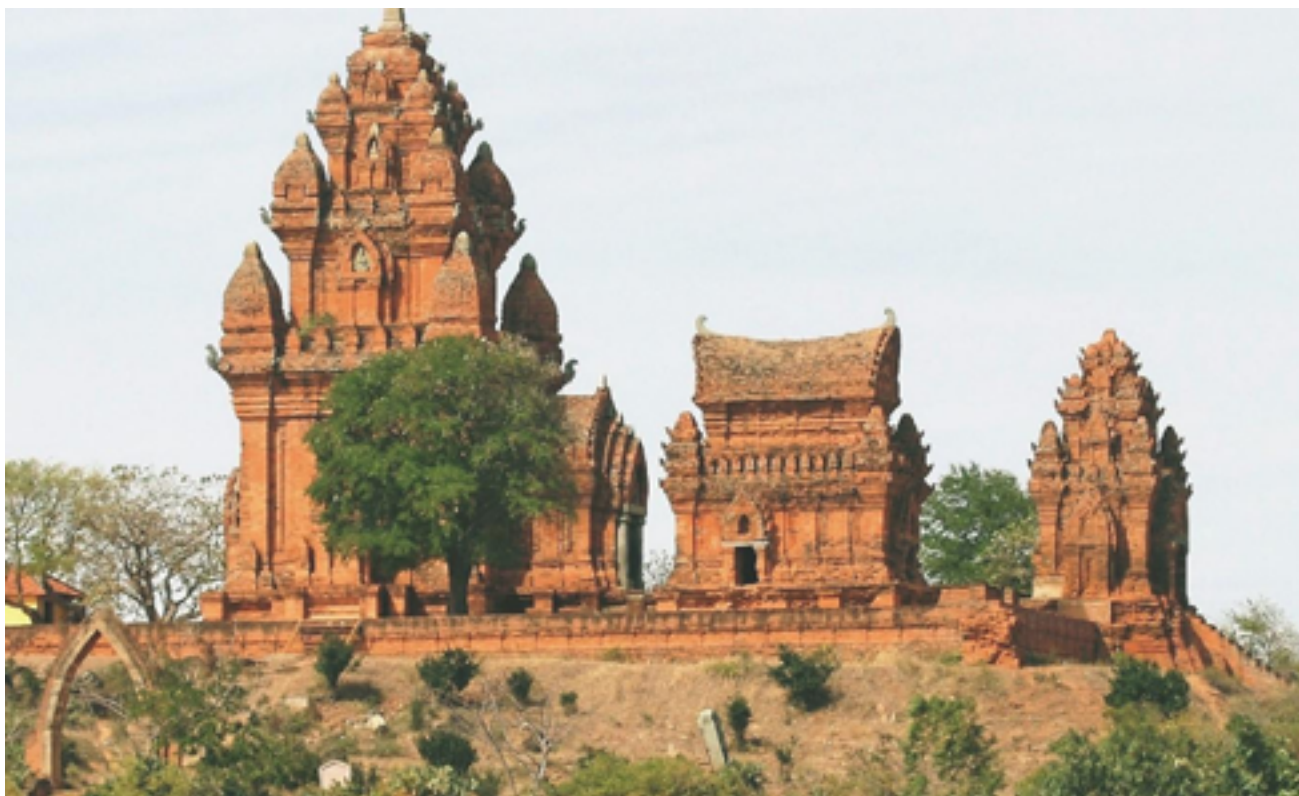
Fig. 5: Po Klaong Girai temple. **Source:** Ninh Thuan Provincial Museum, photo by author, 2016.

The Po Klaong Girai temple complex is situated on Trầu hill in Phan Rang–Thap Cham city. This complex, dedicated to King Po Klaong Girai, was constructed during the late 13th and early 14th centuries and was later rededicated to the king during the reign of the Cham monarch Jaya Simhavarman III in the late 14th century. Po Klaong Girai temple is considered one of the most advanced examples of Cham architecture and construction techniques (Tran Ky Phuong 2007: 138). In the early 20th century, the temple had an abundance of unique architectural details, as noted by Parmentier (1909: 96). Unfortunately, the temple fell into ruin and today only a few towers remain among the ruins of the central tower, entrance tower, and southeast building.

This research found that Po Klaong Girai temple is considered to have the best conservation work in Ninh Thuan province. It is in relatively good condition when compared to other Champa temples in Vietnam, with successful consolidation methods employed by conservation specialists that have helped in its preservation and maintenance. However, the use of cement in the conservation process has resulted in the rapid erosion of the original brickwork, spreading to the surrounding bricks and ultimately creating more harm than good. This same issue is present at Po Klaong Girai temple, where new bricks are now covered in a black patina of surface lichens (Kwiatkowski and Hoang Dao Kinh 1995).

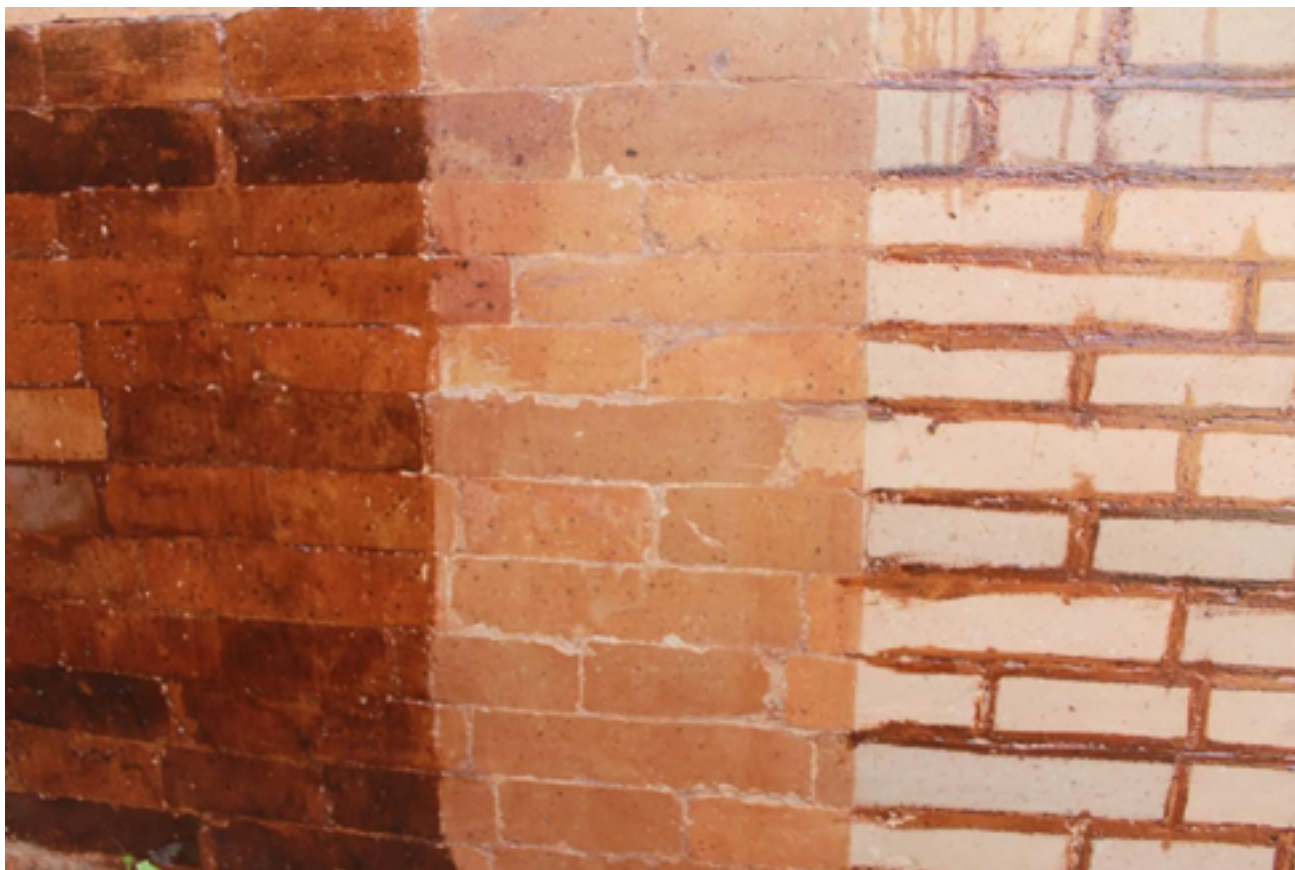
Conservationists often used the temple as a lab for their experiments. This is particularly true in this case. For instance, 1m² of the wall was divided into three small parts to test different methods of a chemical nano-spray technique or “phun sơn thép vàng”. This is a serious violation of the principles of restoration and this fact has been brought to the attention of the local authorities responsible for conservation projects in Ninh Thuan province. However, the experiments still continue.

Fig. 6 Direct testing on the body of the Po Rome temple with three different segments. **Source:** Photo by author, 2012.

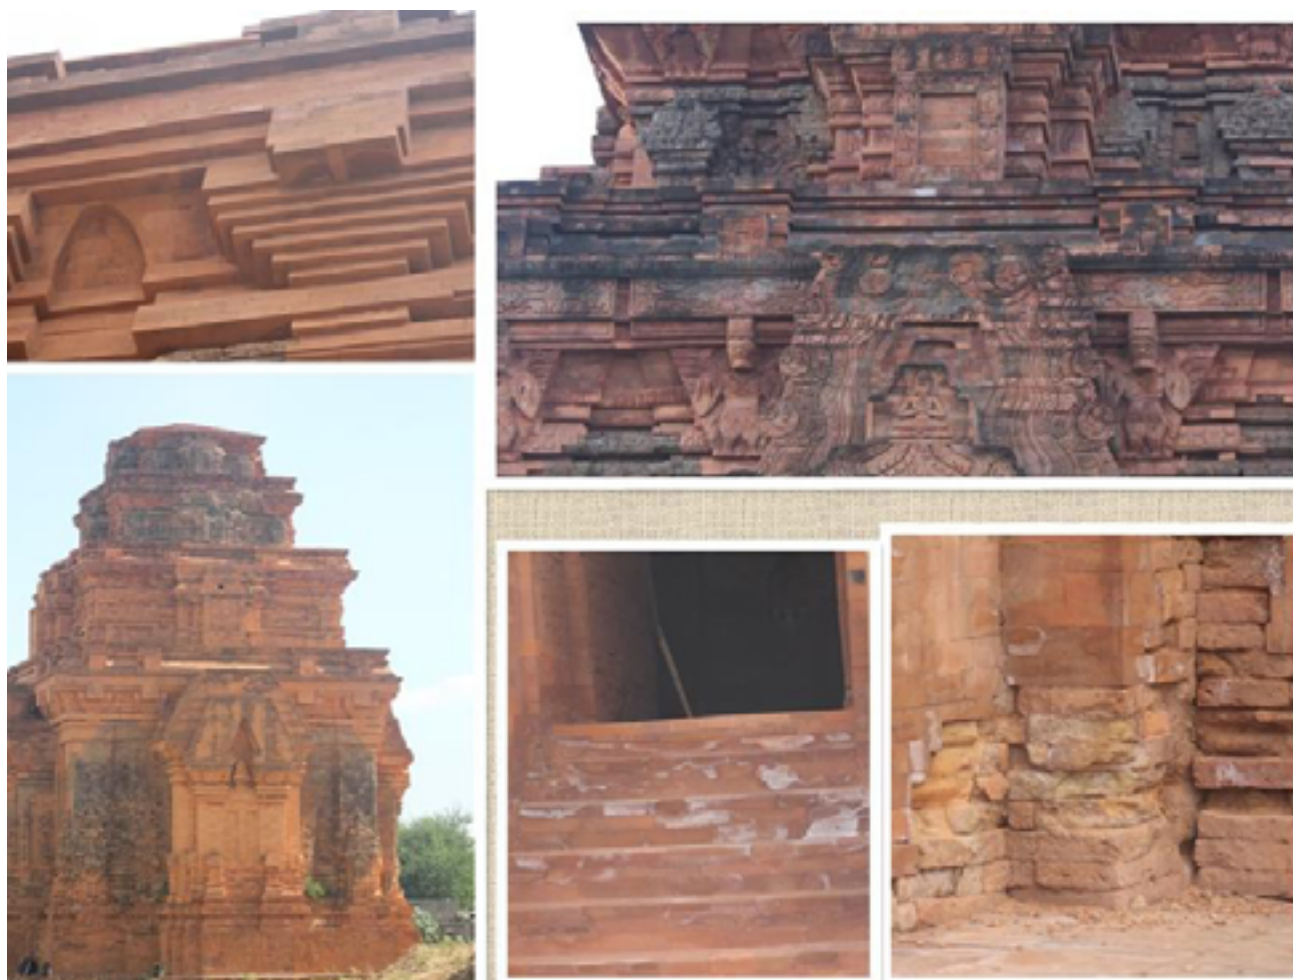
A similar issue was the decision by the conservationists in using new bricks in conserving the Hoa Lai temple. In particular, the bricks used in conservation began showing signs of decay before the project was completed. The Institute for Building Science and Technology conducted experiments with materials of uncertain origin in the restoration (Ho Xuan Tinh 2012: 2). The debates and discordant opinions voiced about the various methodologies of restoration on the brick temples have been well broadcast (Tran Ky Phuong 2008: 29); yet the Institute for Building Science and Technology continued to experiment on the towers and its specialists have proceeded to use their new construction methods on the Hoa Lai temple.

Because the bricks in the Hoa Lai temple were already degrading, conservationists had to halt construction many times. Still, despite problems they continued with the work (Ho Xuan Tinh 2012: 2). The methods of restoration with substandard bricks and experimental adhesives became widely used for almost all the temples. As a result, conservation projects continue to damage this and other

temples. After just a few years, almost all the temples with new bricks and experimental adhesives have degraded or otherwise decayed. More critically, the mortar powder used decays in rain and erodes the surfaces of the original bricks. The new layer of powder formed is likely a caustic agent that accelerates erosion to the bricks of the towers. Furthermore, the new bricks at the base of the West and Southern towers retain moisture, a condition that further places the original bricks at risk. New bricks are fraught with a blight of surface flaws, compromised of biological organisms such as black patina and lichens. Currently, the Hoa Lai temple is heavily damaged from the impacts of the conservation.

Fig. 7 Current conditions of the Hoa Lai temple due to new conservation work. **Source:** Photo by author, 2012.

The evidence shows that the experimental use of bricks and mortar has led to the rapid erosion and decay of the Hoa Lai temple. Therefore, conservationists must exercise caution when implementing new methods to preserve ancient brick buildings, especially those with such significant cultural and historical importance as the Champa temples. It is vital that conservation efforts focus on preserving the original architecture using traditional methods, rather than risking the loss of valuable heritage through arbitrary experiments. (Baer and Livingstone 2015, Camuffo et al. 1999).

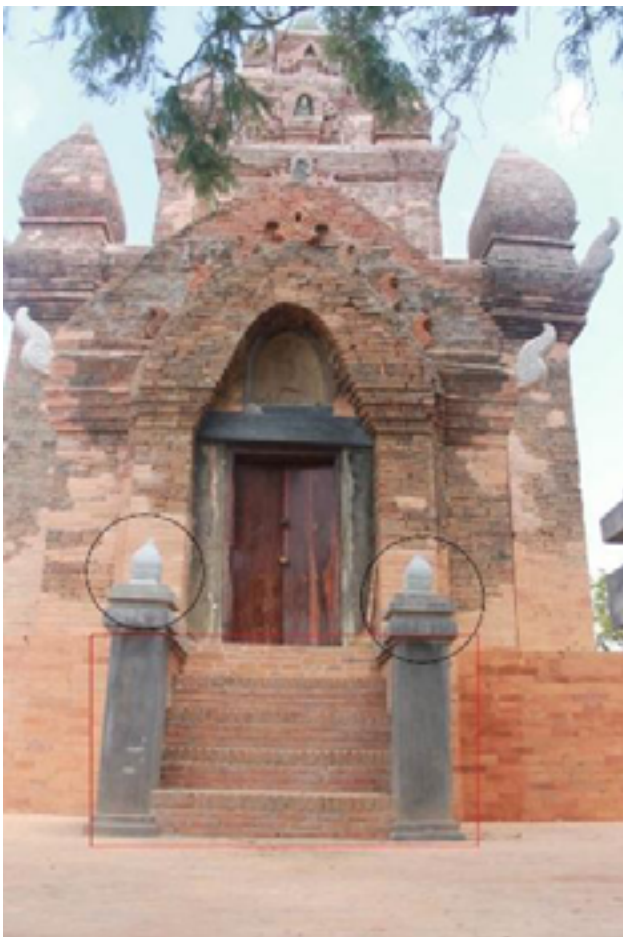
The conservation efforts at Hoa Lai and Po Rome temples have resulted in unintended consequences such as changing the original architectural details, decorations, and motifs on the surfaces of the temples. These mistakes are a result of a lack of knowledge and experience in historical conservation and archaeology site management. Despite acknowledging the need for careful consideration of methodology, inappropriate restoration practices continue to be used. The negative impact of these practices is evident in the case of Hoa Lai temple where the mistakes of the past have led to new problems.

Fig. 8 Some decorative objects characterized Kinh cultural features are added to the Po Rome temple. Source: Photo by author, 2013.

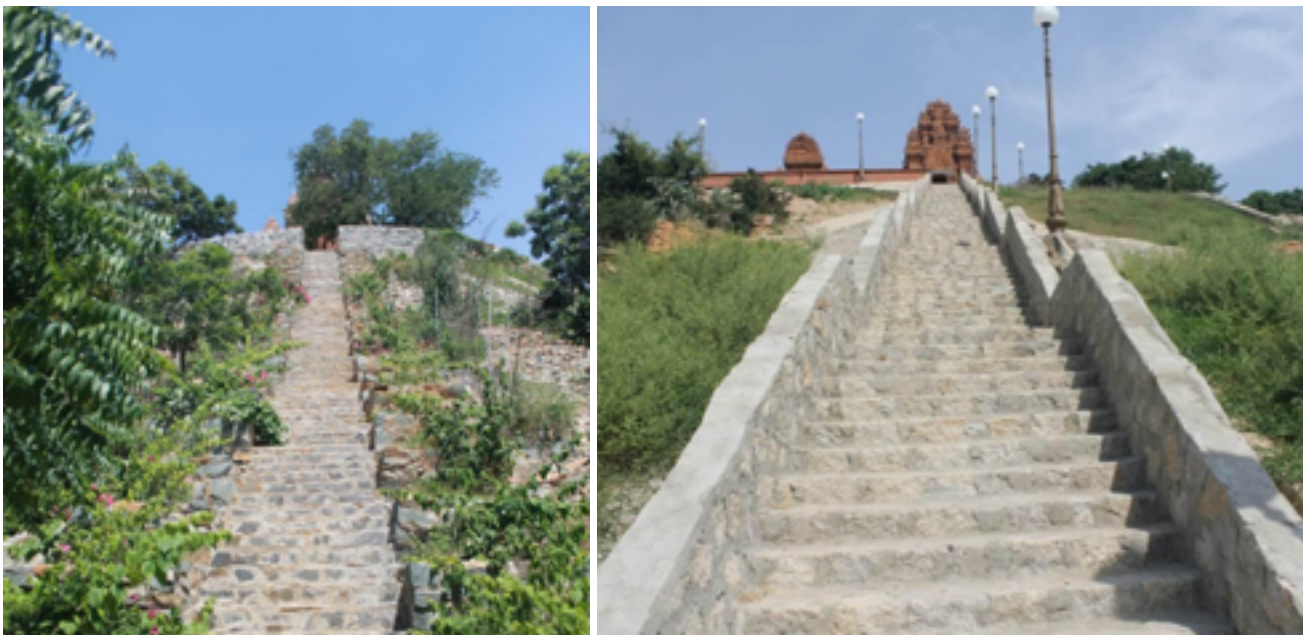
The decision to construct a new entrance on the Po Rome and Po Klaong Girai temples that goes against the traditional practices of Cham culture is deeply concerning. In Cham culture, the east direction is considered sacred and reserved only for gods, while the west is typically avoided for entryways in traditional homes and buildings. However, the architects involved in the restoration of these temples chose to create a direct entrance to the central temple from the east, disregarding the values and traditions of Cham culture. This decision not only shows a lack of respect for the cultural significance of these sites but also highlights how the Cham community has been excluded from the preservation and management of their own ancestral heritage. Furthermore, the new entrance alters the original design and aesthetic of the temples and undermines their historical integrity. It is essential that any restoration work takes into account the cultural beliefs and practices of the community and works to preserve the authenticity and historical value of these important sites.

Fig. 9 & 10 The new entrance from the East offends traditional Cham beliefs about temple entrances. **Source:** Photo by author, 2013.

The negative issues currently affecting the Champa temples require urgent attention from those in authority. For instance, the entrances of Po Rome and Po Klaong Girai temples were recently realigned in accordance with Cham spirituality. However, this research argues that Cham people should have a greater say in the conservation of their ancestor's temples. Previous conservation efforts have negatively impacted Cham religious practices, and it is important to consider the spiritual values of the Cham people in any conservation strategies.
